Resolving High Vibrations of Shipborne AC Plant Using OMA / ODS Analysis

Author: Cdr NSS Pandey (Trial Officer, MTU(Mbi)), Capt Jasvir Singh (Jt. OIC, MTU (Mbi)), Cmde UC Talwelkar (DGNATAA, MTU(Mbi))

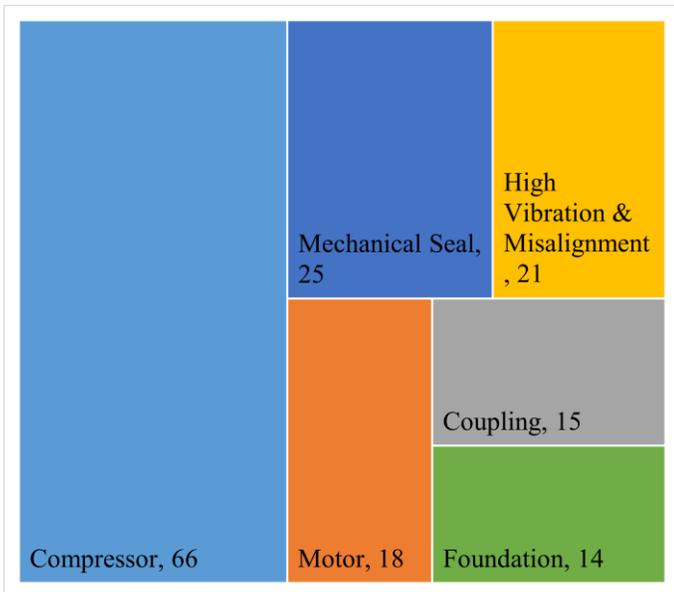
Distribution of the defect serials indicates that almost 30% defects correspond to high vibration, misalignment, coupling and foundation related defects. Tree map placed at Fig.1 is relevant in this regard.

Fig. 1: Comparative Study of Defects – AC Plants

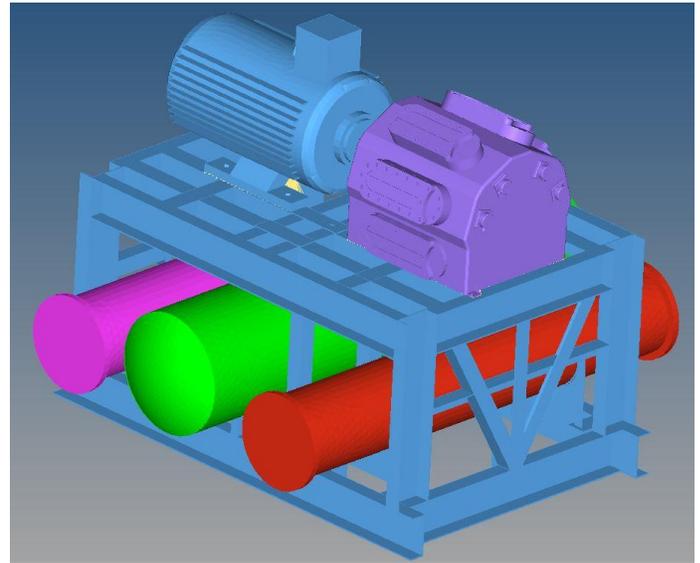
The AC plant is mounted on a raised platform of 120 cm height as indicated in Fig 2. The foundation was suspected to be weak and thus contributing towards increase in vibration levels.

Fig 2: AC Plant Setup with Foundation

The raised foundation (120 cm height) coupled with mounts located below the frame and not below compressor/ motor posed a unique problem. This high foundation made of C-section frames was considered to be weak for such an equipment setup. Further, absence of proper securing arrangement can lead to compressor/ motor getting misaligned during exploitation. Repeated failure of tyre coupling and high vibrations indicated that misalignment in dynamic condition could have been the other reason leading to repetitive failures onboard.

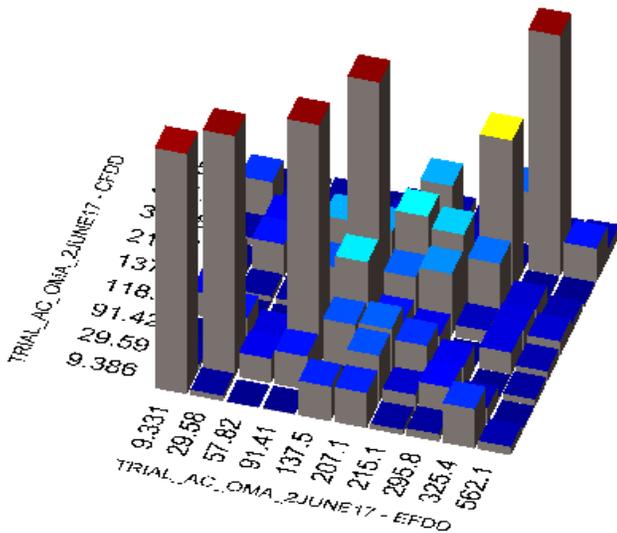
OMA was undertaken on one AC plant using 6-Channel LANXI with PULSE software. The structure geometry used for the analysis included 28 points for the equipment foundation and 06 points each for the motor / compressor. Results from OMA indicated that 2nd natural frequency of foundation was coinciding with 1X of compressor RPM. In addition, the 3rd natural frequency of foundation was coinciding with 2X of compressor RPM. A result of OMA from the Pulse software used for OMA/ ODS analysis is as indicated in Fig. 3.

Fig. 3: Before Foundation Strengthening

The above results clearly indicated that the structure required additional stiffeners which would ensure that the foundation natural frequencies moved away from the forcing frequencies. In addition, the ODS analysis indicated the approximate locations on the foundation frame where additional strengthening was required. However, the same had to be finalized based on maintenance envelope available onboard. Accordingly, detailed feasibility study was undertaken onboard each ship. Post strengthening of the foundation; alignment was undertaken whilst adhering to stringent tolerance limits using Laser Alignment Tool.

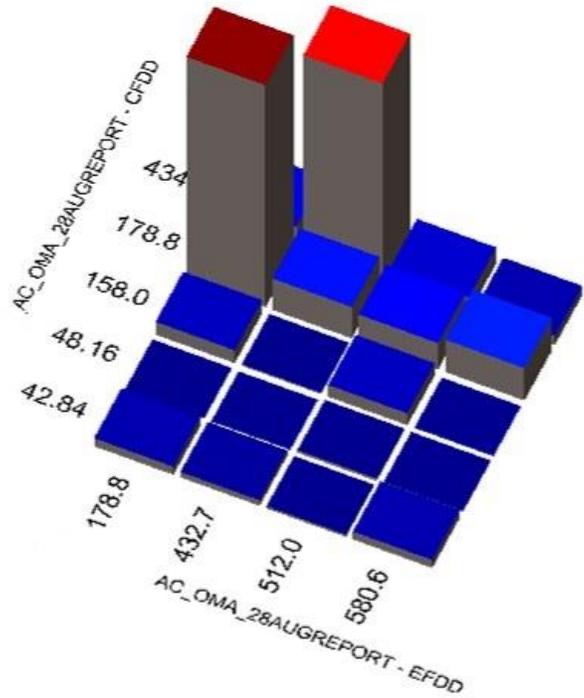
work undertaken. Repeat OMA indicated that the structural modal frequencies have moved away upto 6X of motor rpm and thus unlikely to conflict with forcing frequencies present in the equipment and its foundation setup. Congruence plot from PULSE software for identifying the dominating modes by using Enhanced Frequency Domain Decomposition (EFDD) vs Curve Fit Domain Decomposition (CFDD) is as depicted in Fig. 4.

Fig.4: After Foundation Strengthening

On completion of additional strengthening, followed by alignment within stringent limits / tolerances, repeat vibration trials were undertaken and vibration levels found to be normal. The trials were repeated post 900 hours of exploitation and the overall vibration levels were found to be comparable to past trend. Repeat OMA was also undertaken to identify the new modal frequencies of the structure and therefore validate the

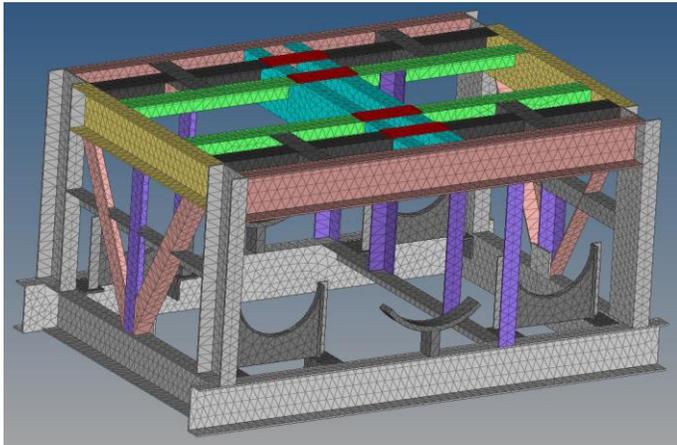
Fig. 5: Equipment Skid with Mesh

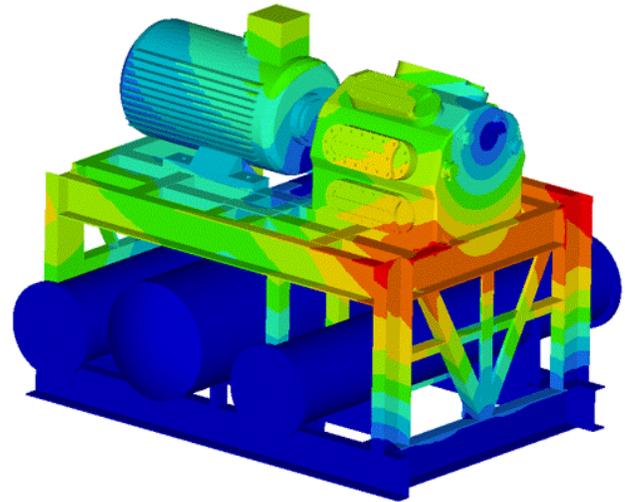
The natural frequencies obtained post modal analysis using Finite Element Method and FFT analysis are tabulated in Table 1 below which validates the results of OMA. In addition, the 178 Hz frequency, which was the 23rd mode was the most dominating frequency as per Finite Element analysis and coinciding with the forcing frequency (6X harmonic of compressor rpm) generated by the equipment. Mode shape depicted at Fig. 6.

Fig 6: 23rd Mode Shape at 178 Hz – FE Analysis
